**Region 9 Enforcement Division  
75 Hawthorne Street  
San Francisco, CA 94105**

<b>Inspection Date(s):</b>	9/28/15		
<b>Time:</b>	<b>Entry:</b> 9:30	<b>Exit:</b> 11:45	
<b>Media:</b>	Water		
<b>Regulatory Program(s)</b>	Clean Water Act NPDES /CAFO Dairy		
<b>Company Name:</b>	Falloncrest Farms / John Weststeyn Cattle		
<b>Facility or Site Name:</b>			
<b>Facility/Site Physical Location:</b>	Ex. 6 Personal Privacy (PP)		
<b>Geographic Coordinates:</b>			
<b>Mailing address:</b>	PO Box 2500, Chino, CA, 91708		
<b>Facility/Site Contact:</b>	Ron Pietersma	<b>Title:</b> Owner/ Operator	
	<b>Phone:</b> Ex. 6 Personal Privacy (PP)	<b>Email:</b>	
	John Weststeyn	Operator	
<b>Facility/Site Identifier:</b>	NPDES CAG018001 / Order R8-2013-0001, General waste discharge requirements for CAFOs (dairies and related facilities)		
<b>NAICS:</b>	112120 Dairy Cattle and Milk Production		
<b>SIC:</b>	0241 Dairy Farms		
<b>Facility/Site Personnel Participating in Inspection:</b>			
<b>Name</b>	<b>Affiliation</b>	<b>Title</b>	<b>Email</b>

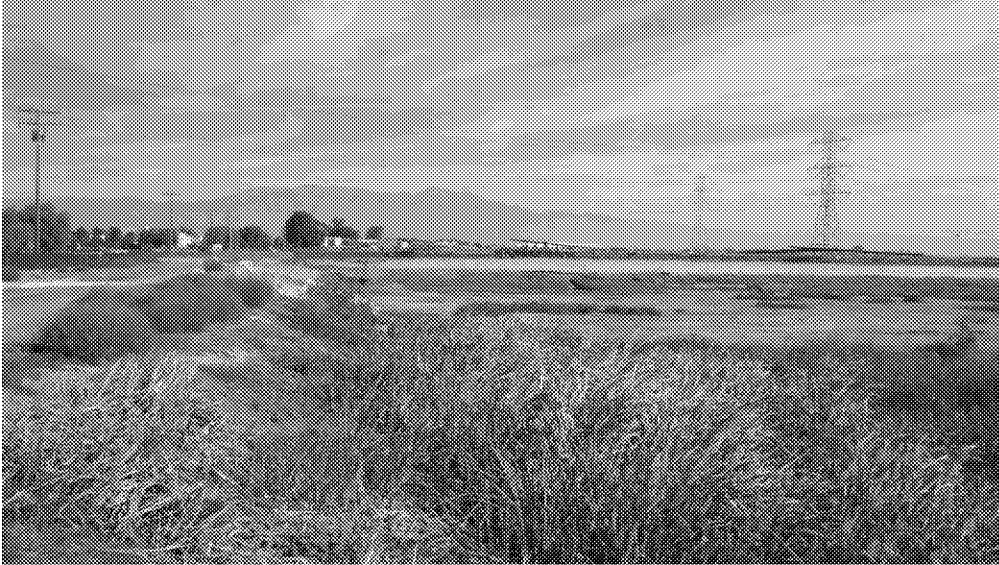
Ponds appeared to contain excess accumulated sediment and excess vegetation (see photos 2, 3, 4). At the time of the inspection, the operator stated the facility began removing solids from the northeastern corner of the north pond about 6 weeks prior to inspection. The area of solids removal was observed in a small portion of the northern pond (see photo 4). The remaining solids in the area appeared to be fairly wet. The operator stated removal of solids was currently suspended due to wet conditions in the basin which prevents a loader from working. The operator stated that they expect to have solids removal completed within about a month, provided the weather remains dry. The solids have been moved to the former calf ranch area to dry before hauling off site.

Photo 2: western edge of Northern Pond: excessive solids and vegetation in pond.

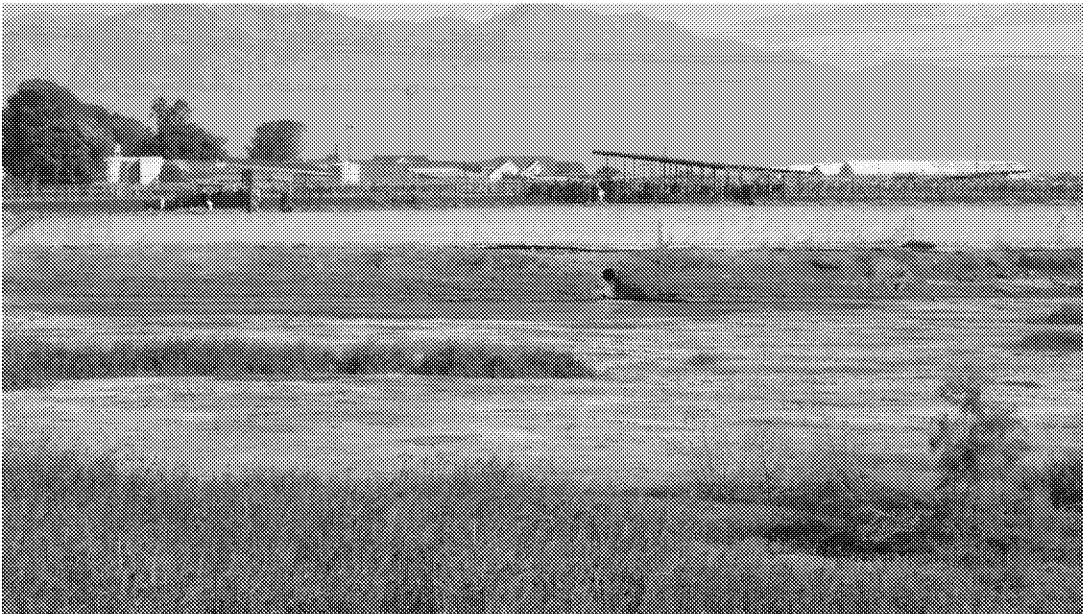
Photo 3: Northern edge of northern pond. Pond actively receiving washwater. View looking north. Excessive solids and vegetation in pond.

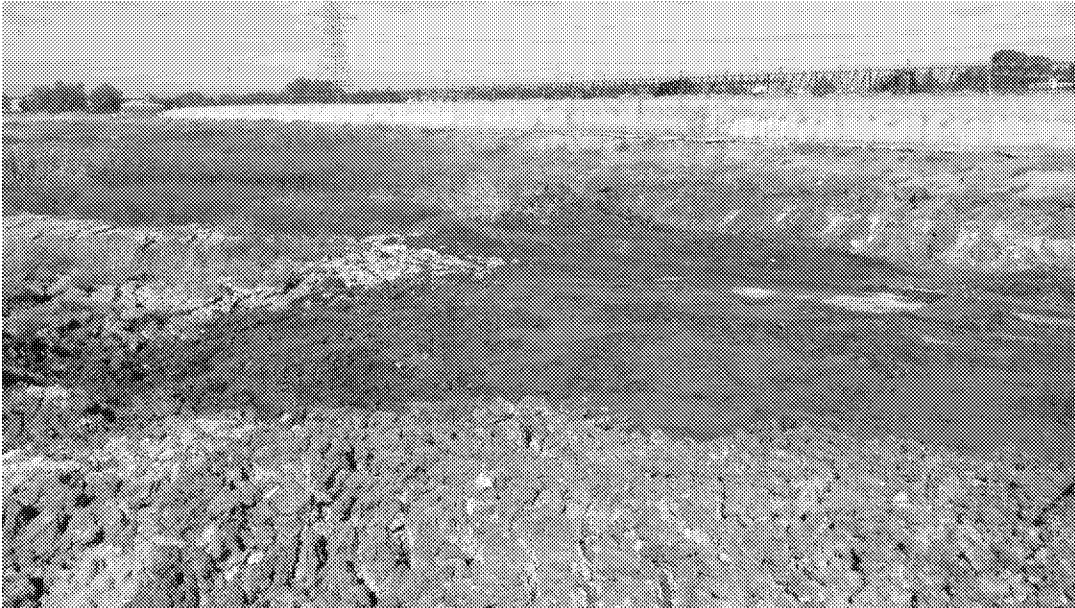
Photo 4: Eastern edge of Northern pond. Solids recently been removed.

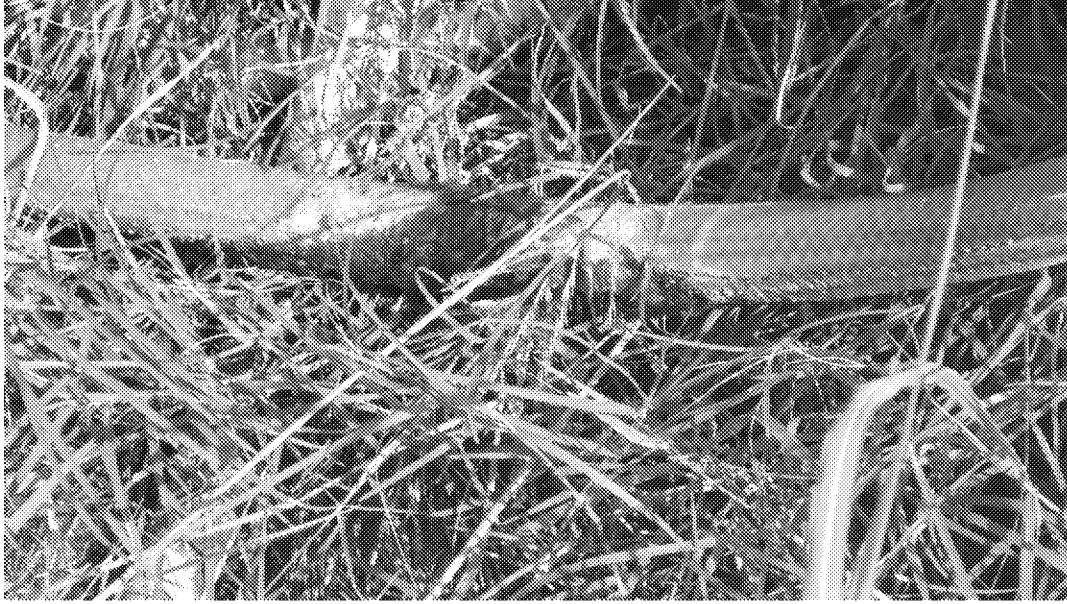
A broken water line was observed draining into the wastewater lagoon (see photos 8-9). Algae growth was observed both on the waterline hose and on the pavement downstream of the leak, indicating the presence of the leak for an extended amount of time.

Photo 8: Broken water hose discharging to southern pond.

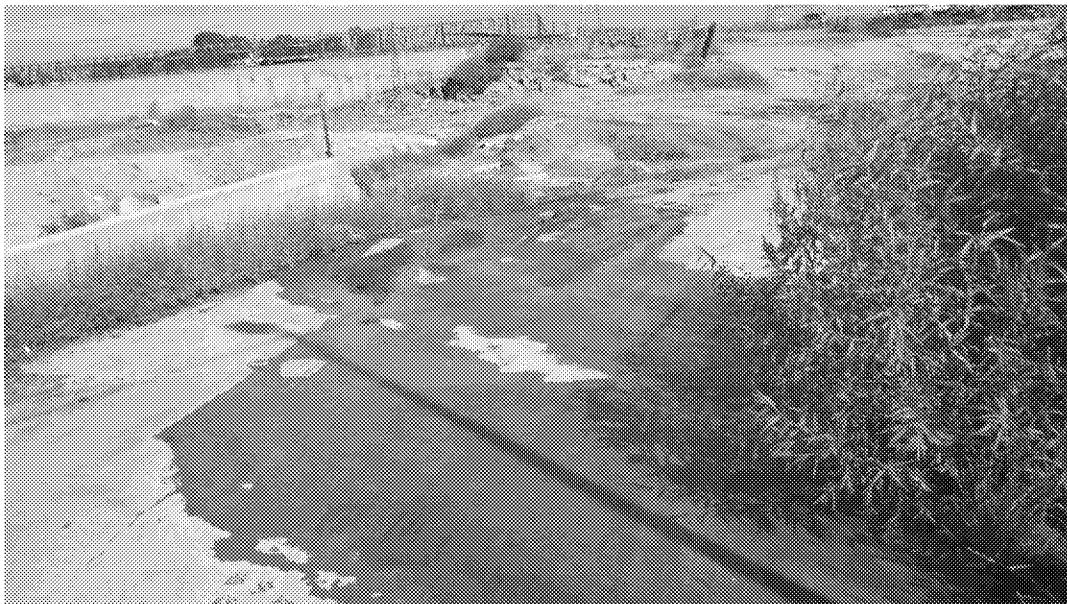
Photo 9: Broken hose discharging to southern pond.

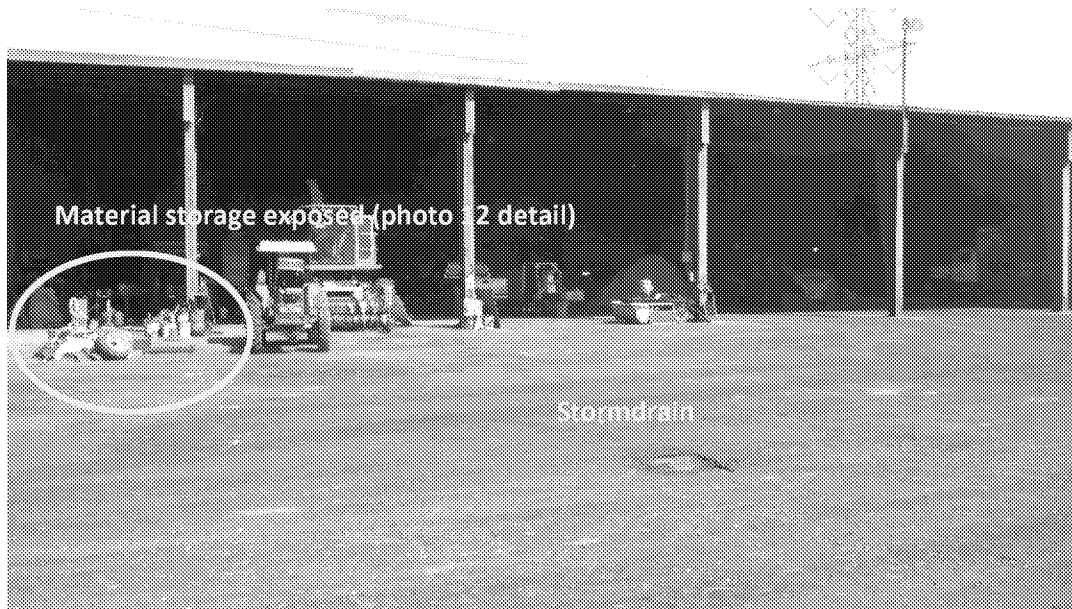
Photo 11: Maintenance area

At the maintenance area, numerous issues were observed of improper chemical storage, improper storage of used oil, evidence of oil leaks, improper storage of a battery, and general lack of housekeeping. A stormwater drain was located in front of the maintenance area (see photo 11):

Open containers of used oil were observed at several locations with potential to discharge to the stormdrain (see photos 11, 12, 16, 17, 18). At least one bucket had a label of "hydraulic oil". Evidence of oil stained soil and oil stained pavement was observed at several locations throughout the area (see photos 12, 15, 16).

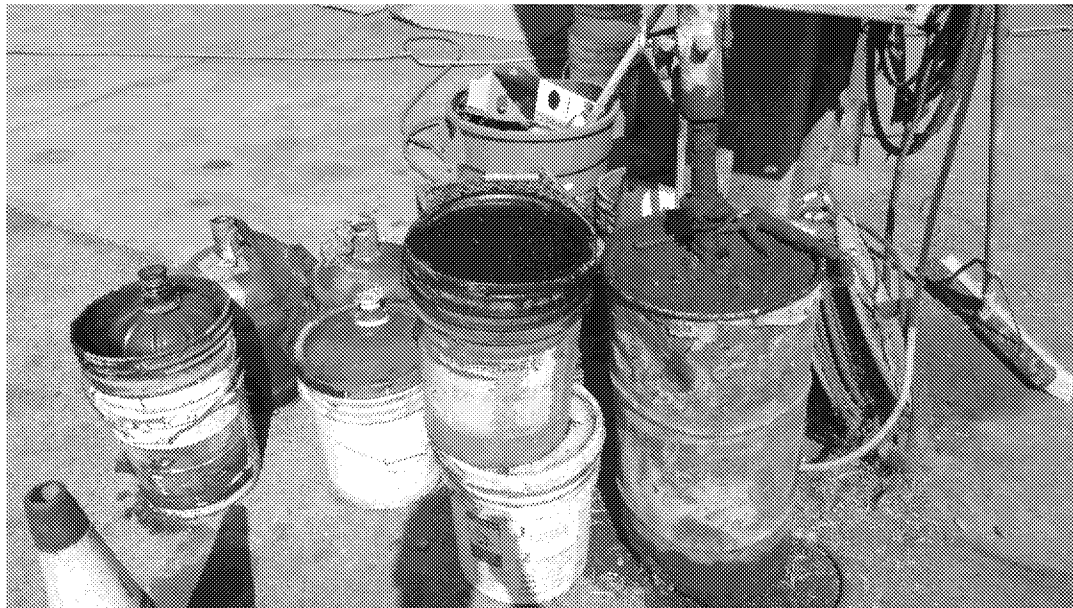
Numerous unidentified containers of liquids were observed stored outside , some leaking, with potential discharge to stormdrain (photo 12, 21).

Photo 12: Maintenance area - detail of Photo 11: improperly stored used oil storage and materials storage.

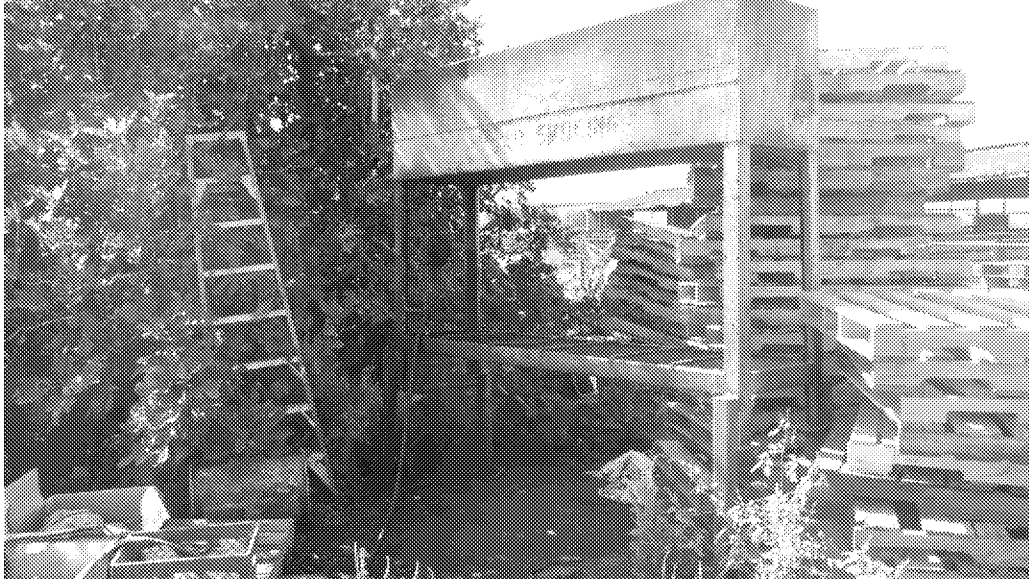
An aboveground rectangular tank was observed with evidence of material leaked onto the ground that appeared to be oil (photo 13, 14, 15). The top of the tank could not be observed and it was unknown if the tank was open-topped or had any liquids stored inside. It was unclear the purpose the tank. "No smoking" was stenciled onto the side of the tank. The valve under the tank appeared to have leaked and the soil beneath the tank was stained.

Photo 13: Maintenance area : tank, leaking valve, spills and staining of soil

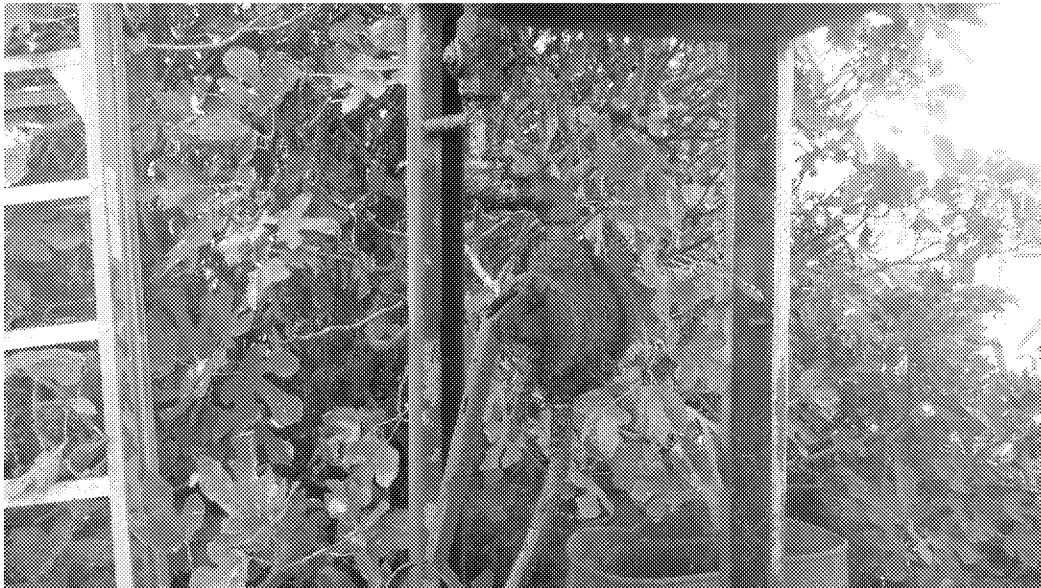
Photo 14: Maintenance area: detail of Photo 13: of leaking valve under tank.

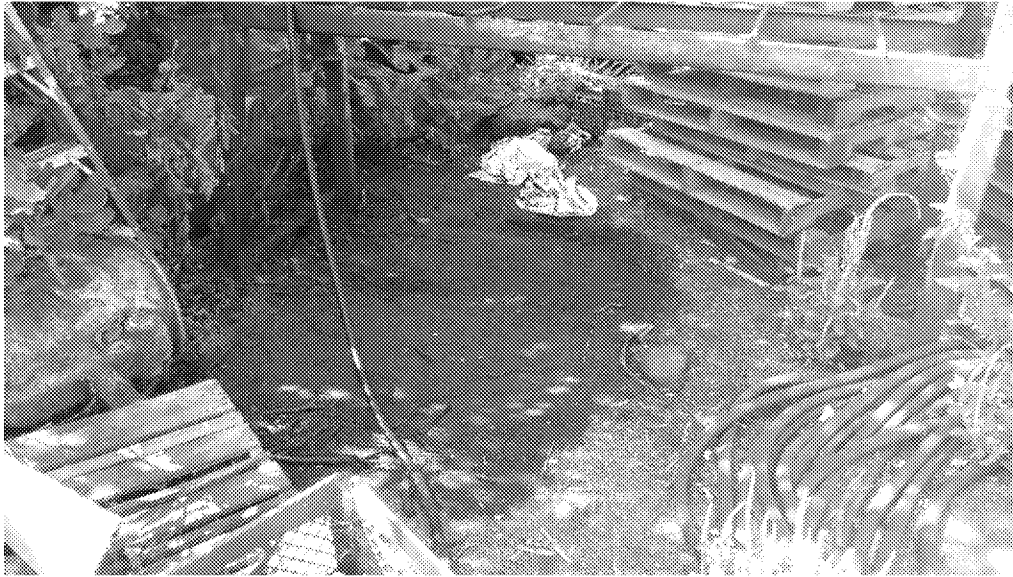
Photo 15: Maintenance area: detail of photo 13: stained soil under tank.

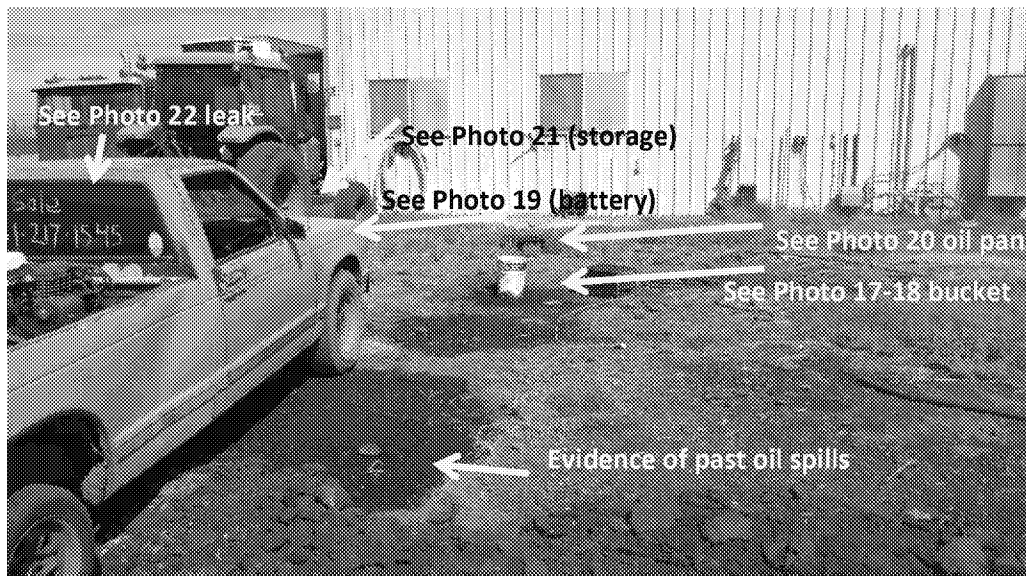
Photo 16: Maintenance area. Southwest corner of maintenance shed. Oil stained soil, improper used oil storage, and improper material storage.

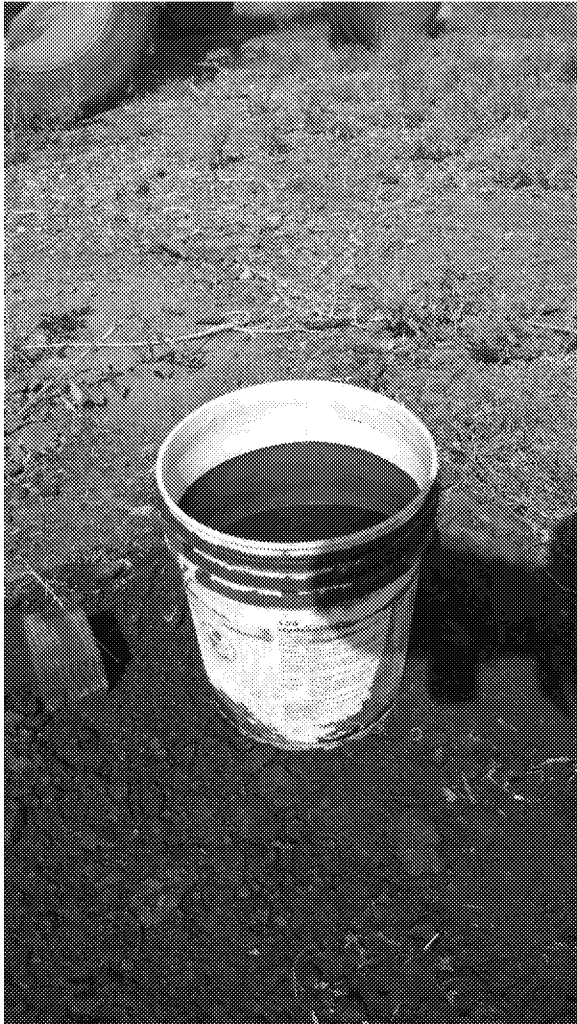
Photo 17 : Maintenance area : detail of  
photo 16: Bucket with used oil

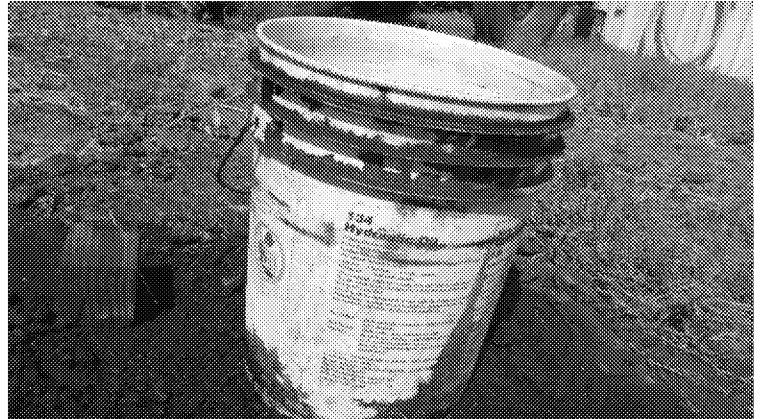
Photo 18: Detail : bucket labeled "Hydraulic oil"

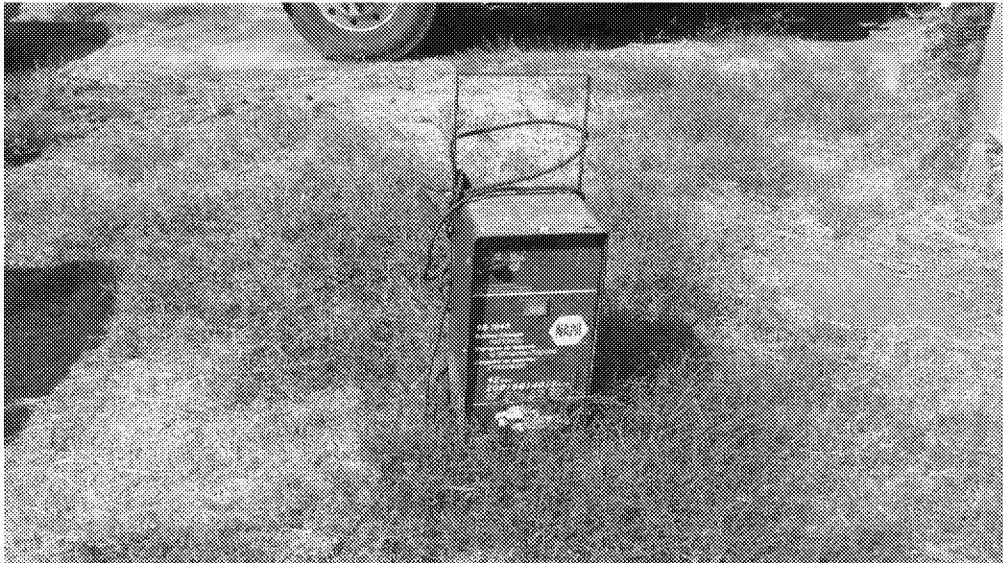
A battery was observed stored outside with potential to leak to stormdrain (photo 19).

Photo 19: Maintenance area detail of photo 16: Improper storage of battery

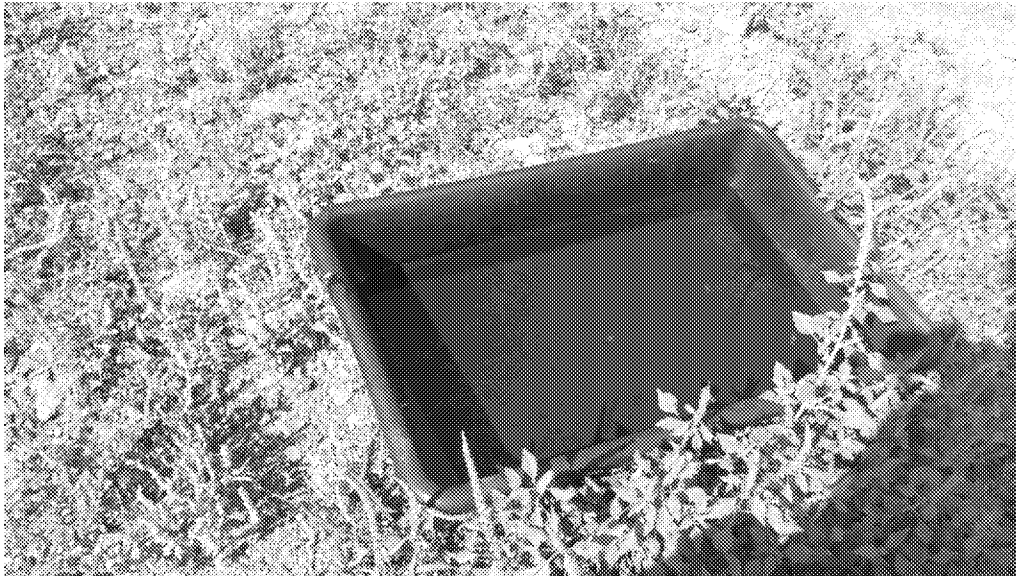
Photo 20: Maintenance area detail of photo 16: Improper storage of used oil pan with several inches of oil accumulation.

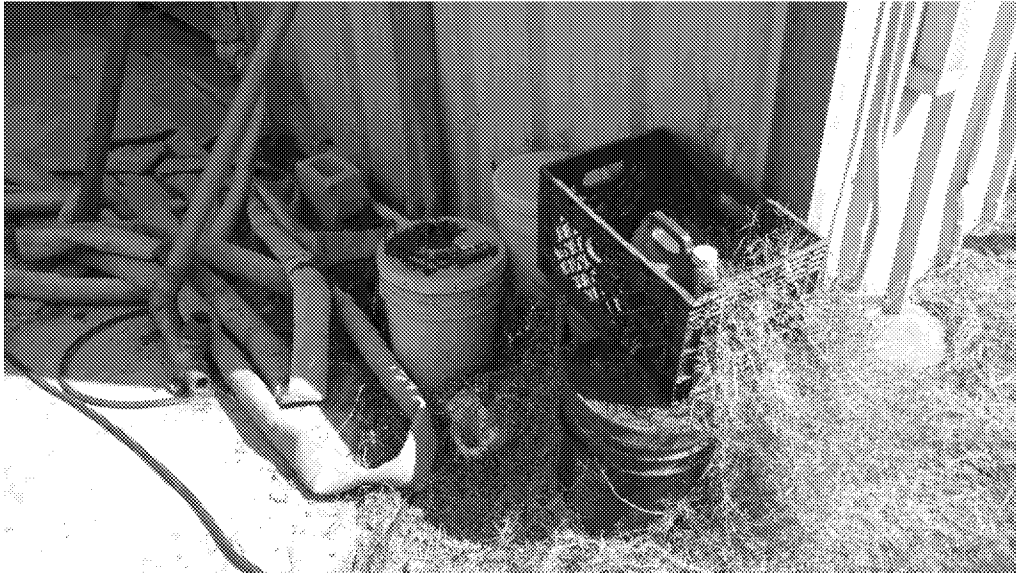
Photo 21: Maintenance area detail of photo 16: Storage of unknown materials at southwest corner of maintenance shed.

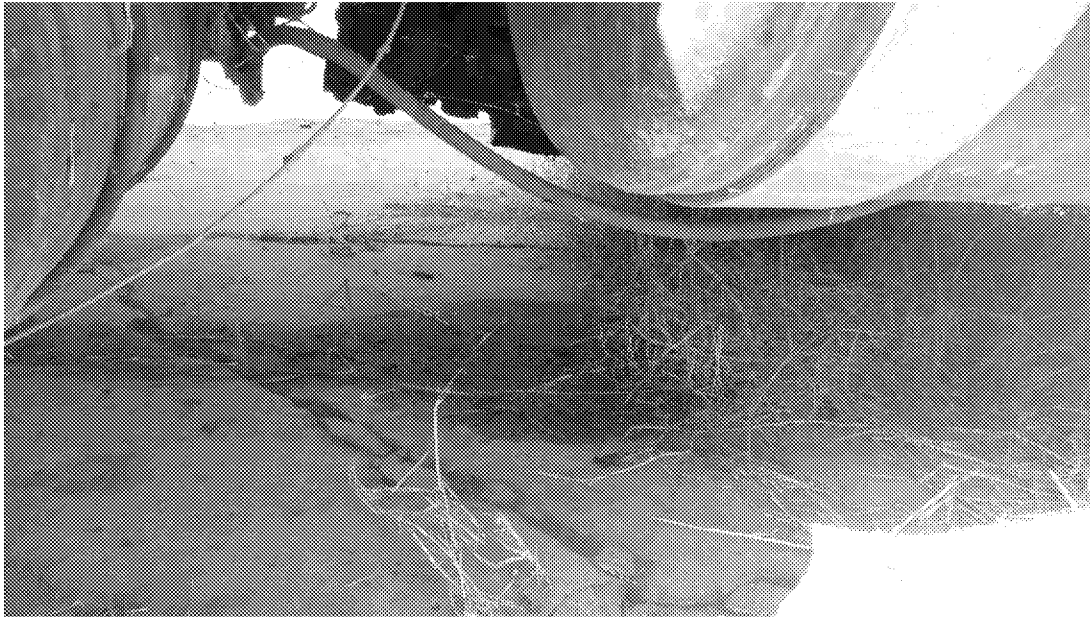
An engine was observed leaking oil onto the pavement with potential to discharge to the stormdrain (photo 22).

Photo 22: Maintenance Area detail of photo 16: active leak from truck engine

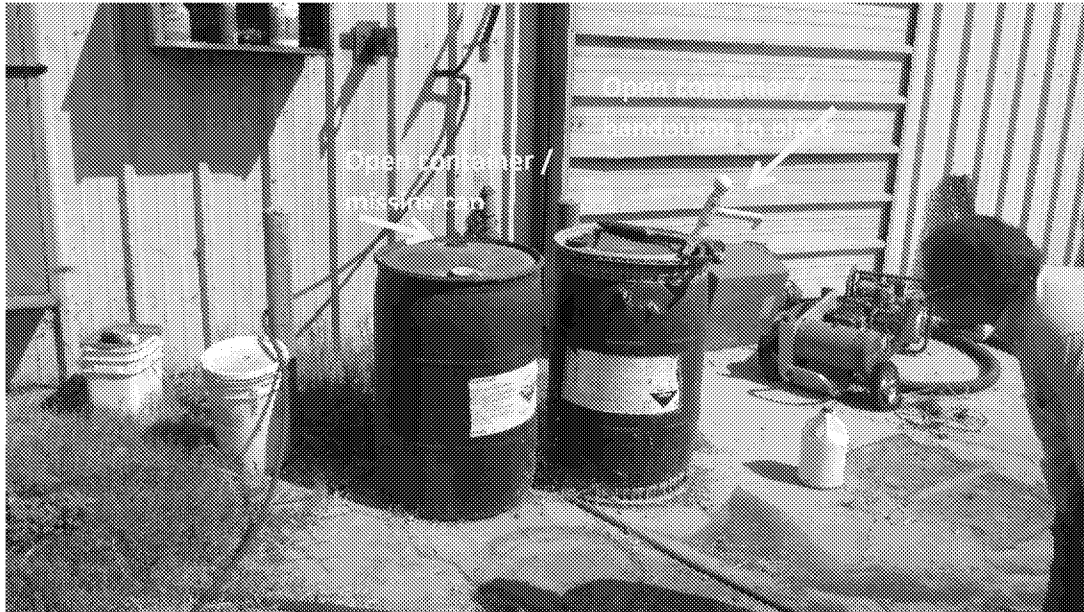
Two 55 gallons barrels were observed without secondary containment with potential to discharge to the stormwater drain. The barrels were both approximately ½ full. One barrel was open due to a missing cap and was labeled "formaldehyde". The second barrel was open due to an installed pump system, and, while the label was partially unreadable, it appeared to be "sodium hypochlorite" brand name "HASACHLOR".

Photo 23: improper chemical storage.

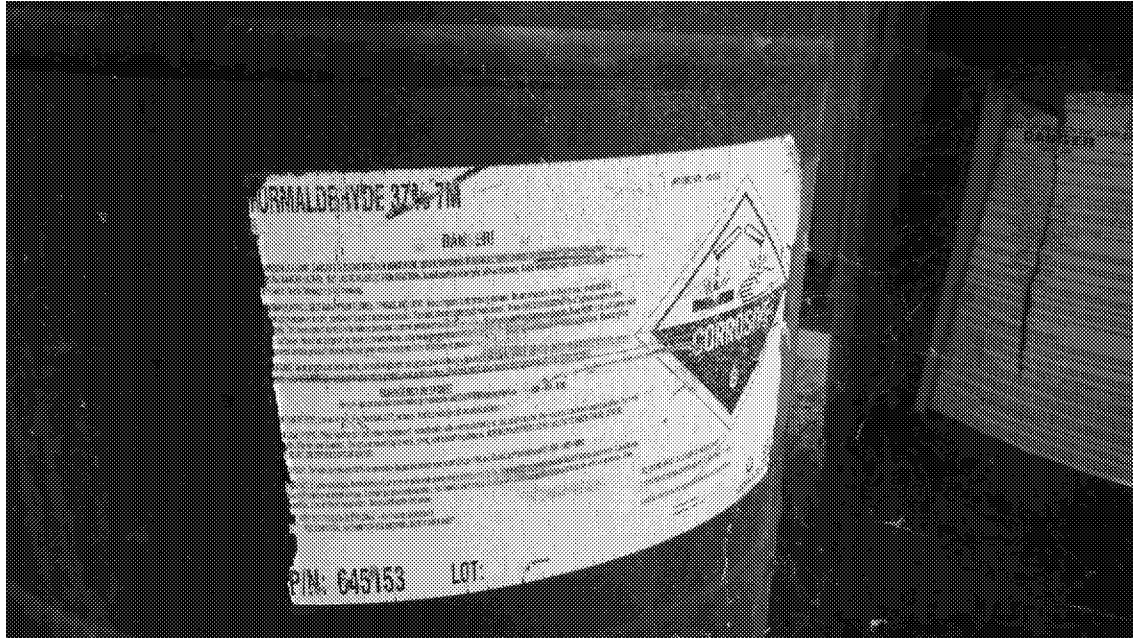
Photo 24: Detail of photo 23: Improper chemical storage, detail label "formaldehyde". Barrel was open, approximately one half full of liquid.

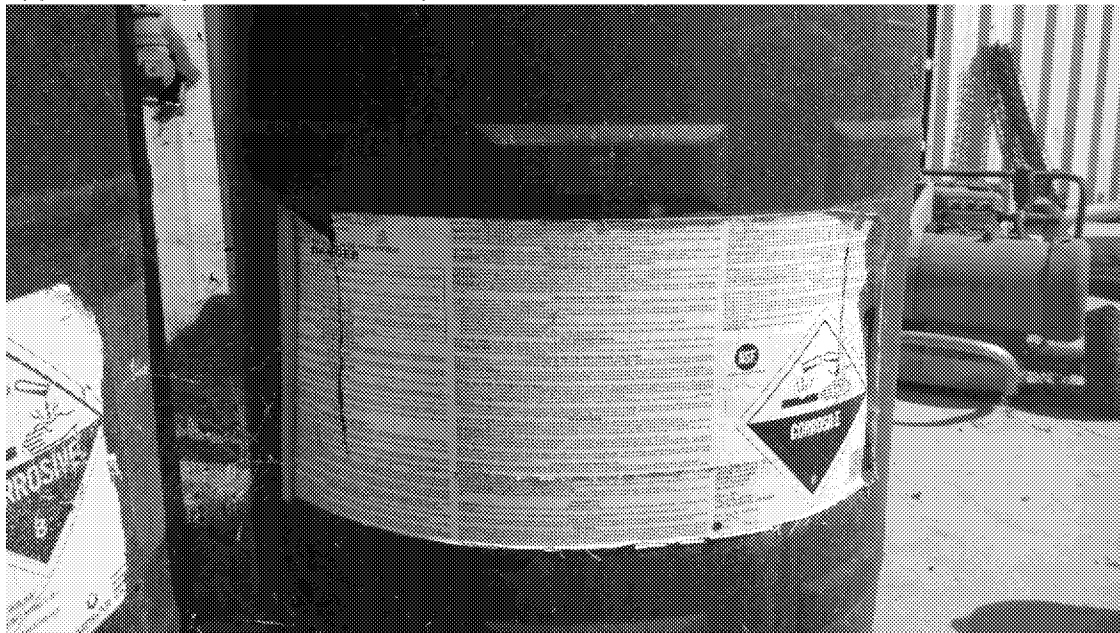
Photo 25: Detail of photo 23: improper chemical storage, detail of label. Label is partially unreadable, but appears to be "sodium hypochlorite" brand name "HASACHLOR". Barrel was approximately one half full of liquid.

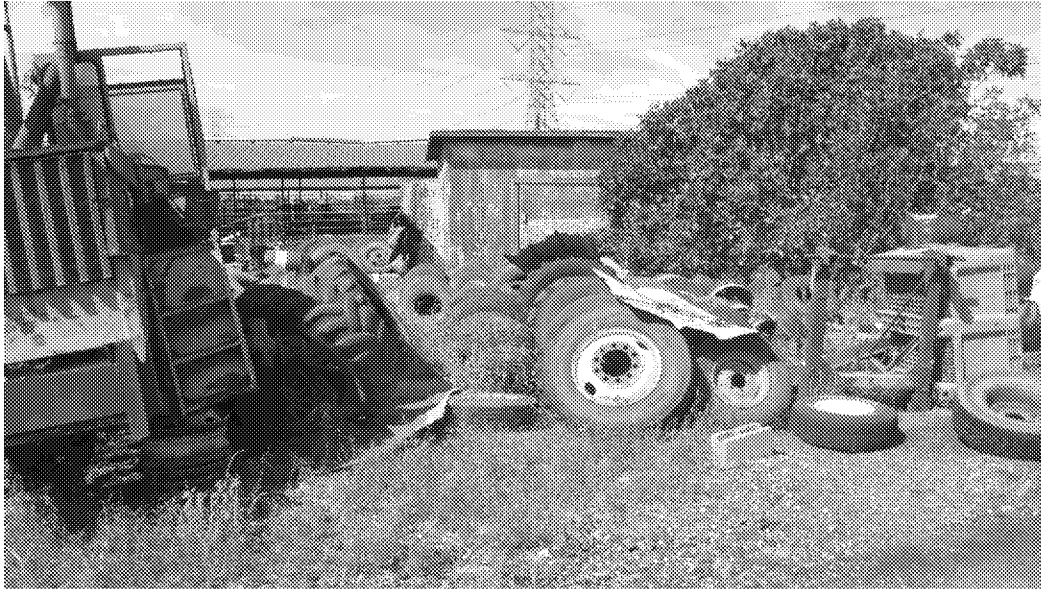
Photo 26: Maintenance area – material storage and used tires disposal.

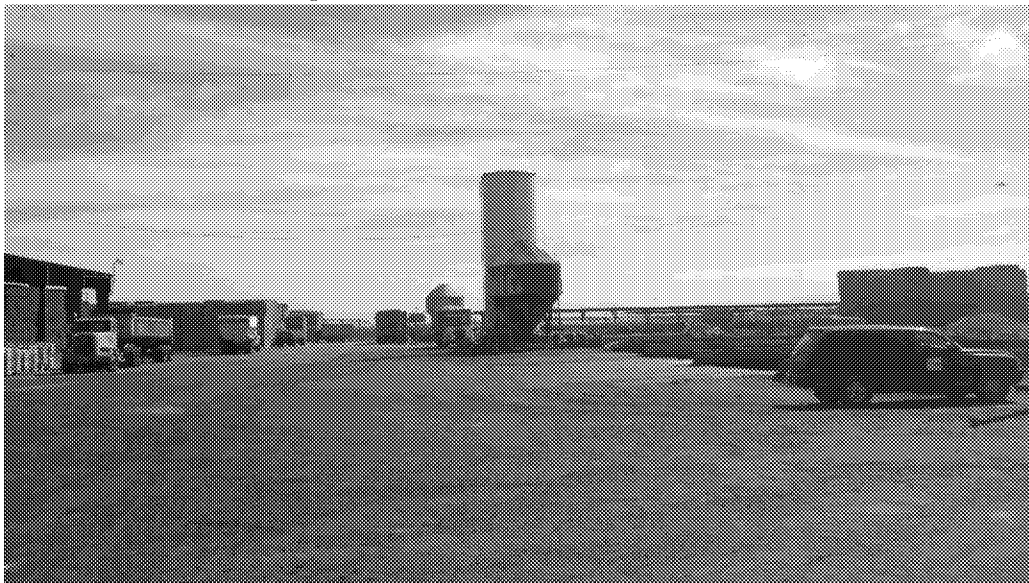
Photo 27: area of mixing feed.

The area at the south end of the maintenance area is used for mixing feed in several concrete basins, including feedstock which may include old ice cream and other milk products (photo 28). The area around the feed area and pavement was stained with material that had the potential to discharge to the stormdrain. (photo 27, 28).

The material was dark black but did not have a sheen and was determined to be feed material tracked out from the mixing tanks and was not oil. At the closeout meeting, the operator noted that curdled milk product can have the black appearance of oil.
